## CONSTRUCTION WORK REPORT

# Pellizzari s.r.l.

## RESTORATION OF BUILDINGS AND CAPITAL ITEMS FOLLOWING THE EARTHQUAKES OF 20 AND 29 MAY 2012

**Site Address:** Via del Commercio, 440 – 41038 San Felice sul Panaro (MO)

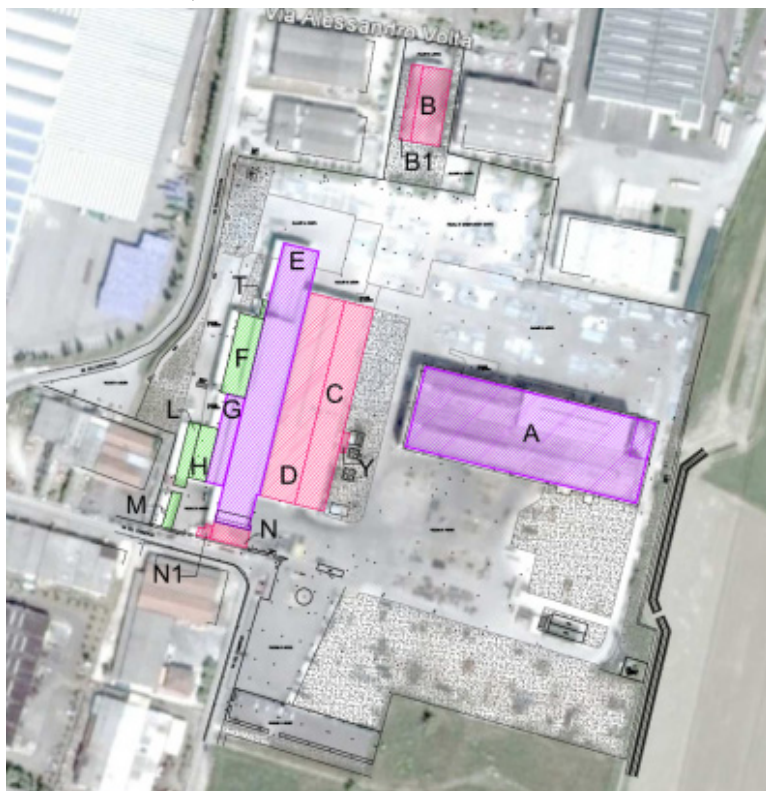
### POST-EARTHQUAKE LAYOUT

structures with SERIOUS and/or VERY SERIOUS damage

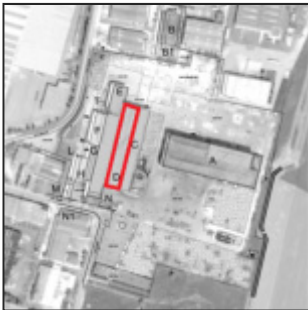
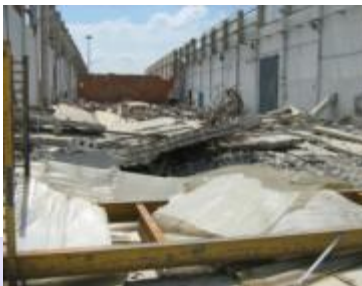
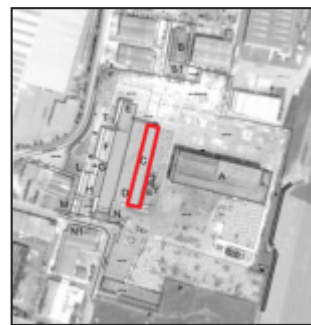
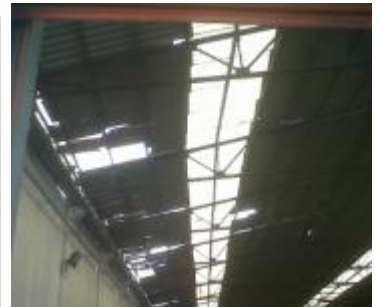
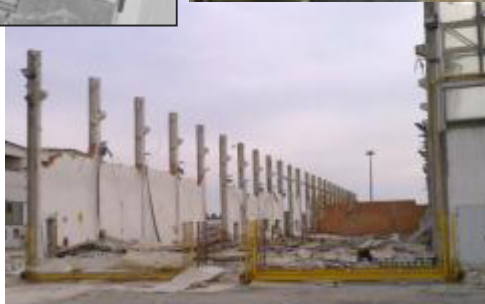
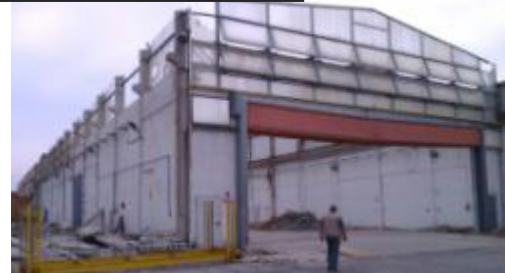
***Industrial building with mono-pitch metal-panel trussed roof, prestressed reinforced concrete supporting structure, and masonry walls.***

Dimensions 115 m x 16.6 m (centre to centre distance), tie level height 9.10 m, apex height 10.50 m.

Unusable after the earthquake because of partial roof collapse and displacement of roof trusses from their seatings.

***Industrial building with mono-pitch metal construction roof, reinforced concrete supporting structure, and masonry walls.***

Dimensions 115 m x 20.5 m, tie level height 9.54 m, apex height 11.58 m.

Roof collapse rendered the building unusable, and a decision was taken to demolish.

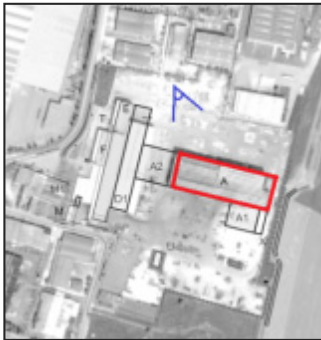
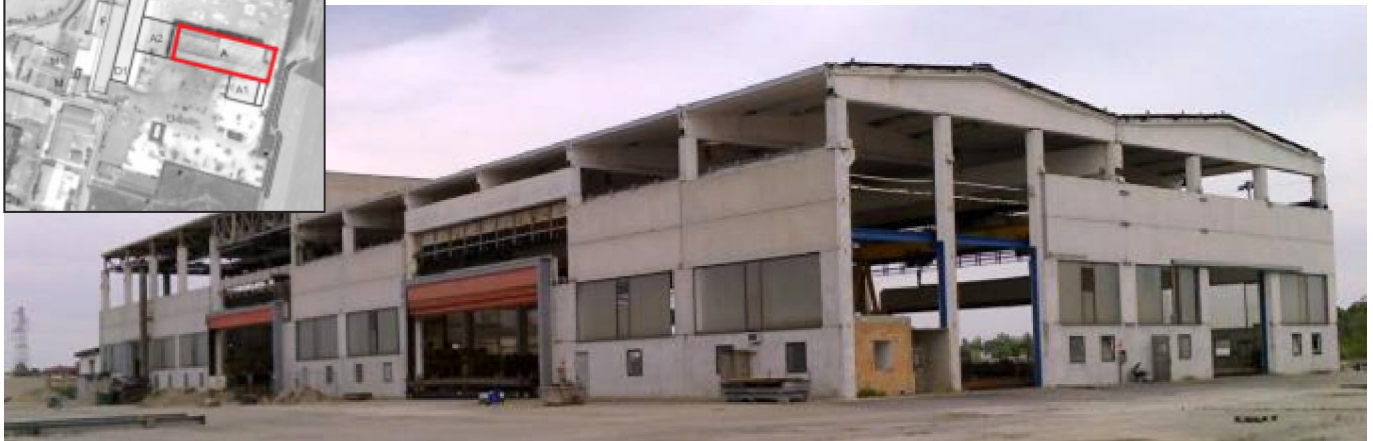
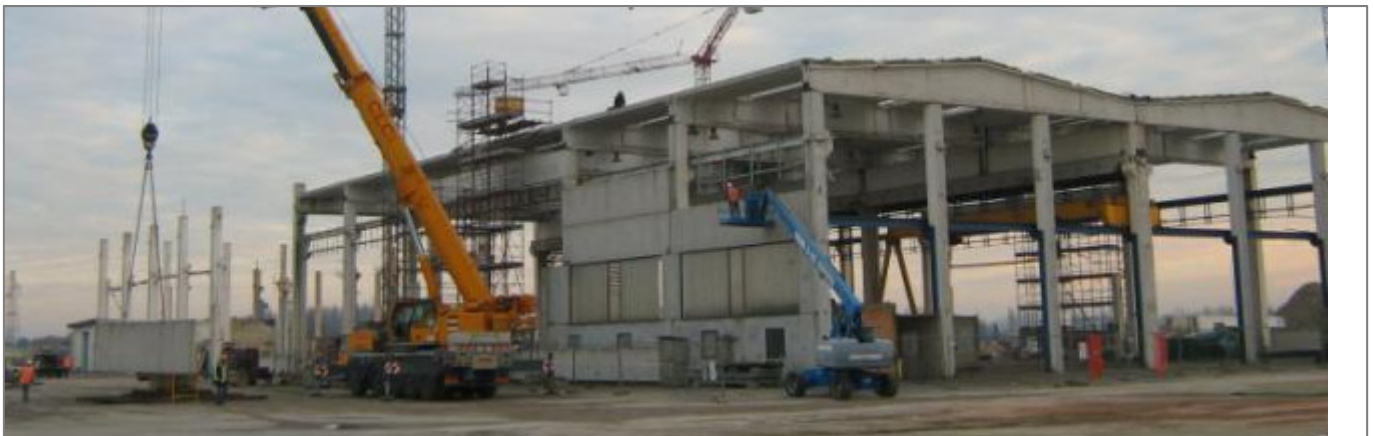
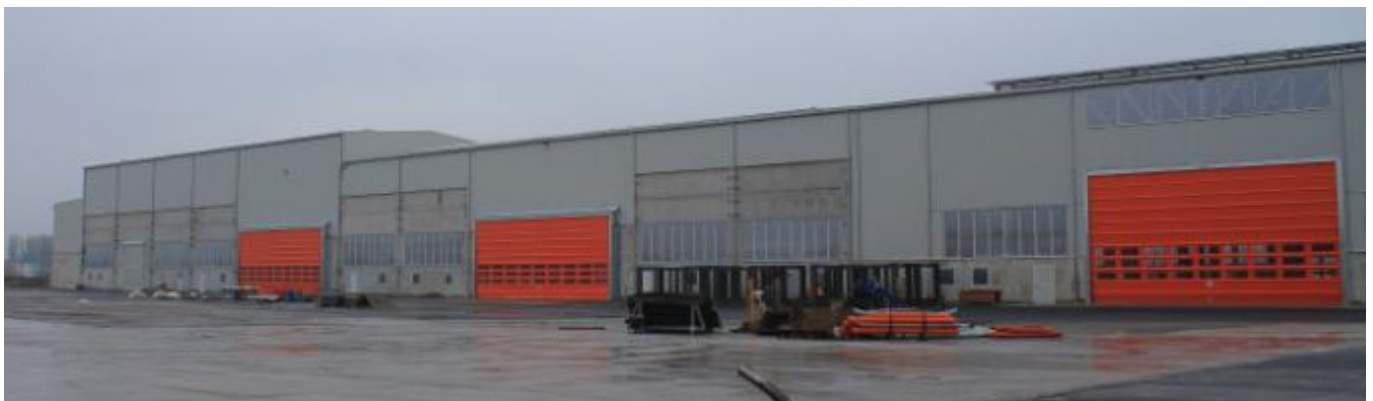
***Industrial building constructed mainly in prestressed reinforced concrete with sandwich panel roof.***

Overall dimensions 131 m x 45.6 m, tie level height 12 m approx, apex height 15.5 m.

The earthquake rendered the building unusable due to collapse and partial detachment of external wall panels and sections of the roof, with damage to two columns at the entrance portal frames.

**RECONSTRUCTION OR UPGRADING WORK**

1. Installation of external metal panels or creation of a roof parapet with safety line
2. Removal of roof covering and replacement with roof panels
3. Re-siting of internal equipment hindering operations
4. Additional operations to ensure the safety of structures and internal equipment
5. Demolition of internal structures hindering new building work
6. Demolition of acid bath in preparation for replacement
7. Demolition of obstructive sections of pre-heat and galvanising oven foundations in preparation for replacements
8. Installation on columns of connection brackets for existing trusses
9. Installation of cladding on stanchions
