## CONSTRUCTION WORK REPORT

# Pellizzari s.r.l.

## RESTORATION OF BUILDINGS AND CAPITAL ITEMS FOLLOWING THE EARTHQUAKES OF 20 AND 29 MAY 2012

**Site Address:** Via del Commercio, 440 – 41038 San Felice sul Panaro (MO)

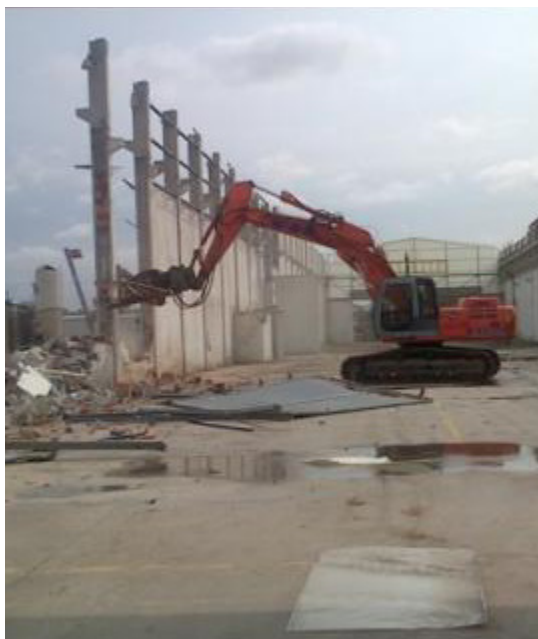
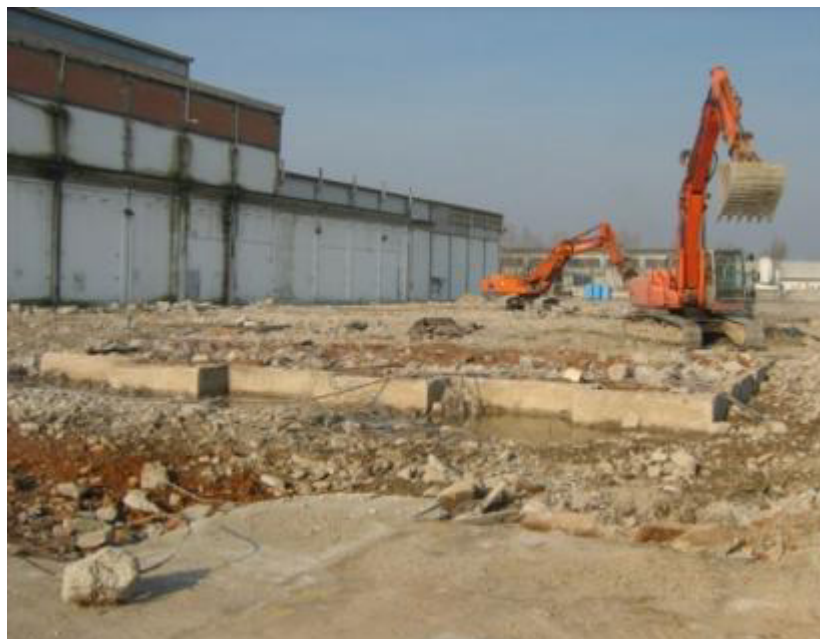
Dimensions 115 m x 20.5 m, tie level height 9.54 m, apex height 11.58 m.

Roof collapse rendered the building unusable, and a decision was taken to demolish.
